KELLY BARNES DAM FLOOD OF NOVEMBER 6, 1977, NEAR TOCCOA, GEORGIA

By  
C. L. Sanders, Jr., and V. B. Sauer  
1979

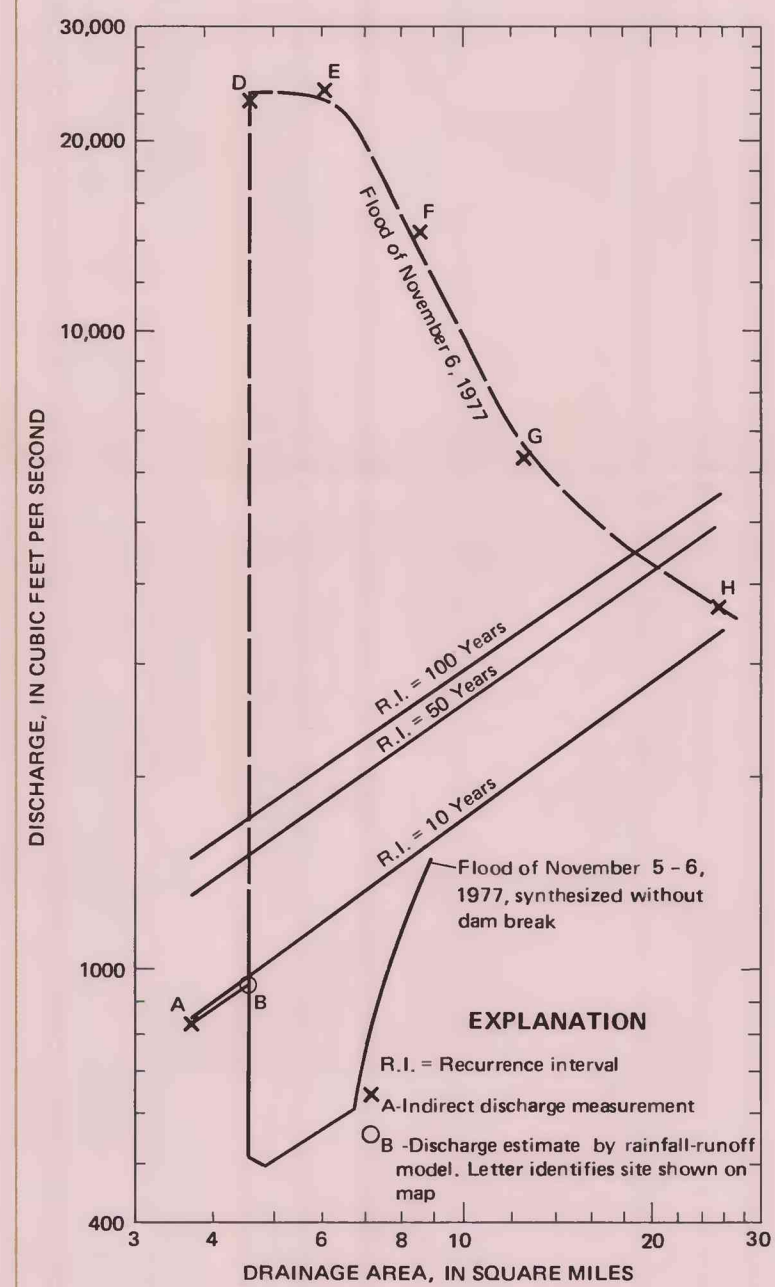
FIGURE 12.—Relation of peak discharge to drainage area for Toccoa Creek.

Conditions for making discharge computations were considered good at sites A and H, fair at sites B, F, and G, and poor at sites C, D, and E. Graphs showing the relation of discharge to drainage area for the observed flood, together with the 10-, 50-, and 100-year regional flood-frequency curves (Golden and Price, 1976), are shown in figure 12. No attenuation of the peak discharge was evident between the dam and Toccoa Falls College (sites D and E). Extreme attenuation occurred between Toccoa Falls College and Highway Road (sites F and G) due to increased overbank storage and rapid changes in stage. Flow at sites F and G was 60 percent and 27 percent, respectively, of the peak discharge at site E.

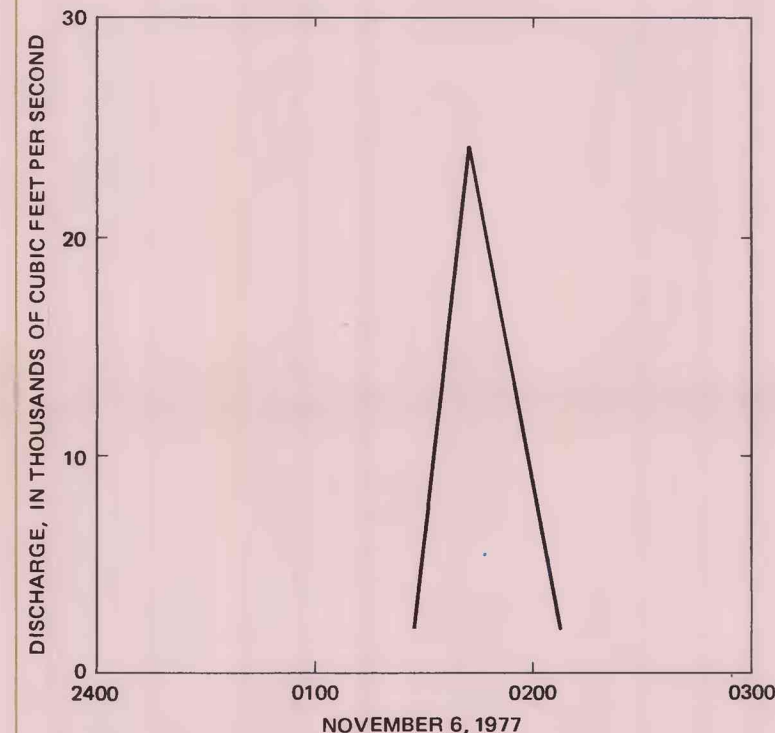
FIGURE 13.—Estimated hydrograph at Forrest Hall Dormitory, 0.7 mile downstream from Kelly Barnes Dam. Timing based on reports of eyewitnesses.

Because this disaster occurred at night, eyewitness accounts of the timing of the flood wave were not consistent. According to one witness, the creek was out of its bank for about an hour at Forrest Hall Dormitory, at the upstream end of the college campus. Other witnesses indicate that the flood waters were out of bank for only about 40 minutes. An estimated discharge hydrograph at Forrest Hall Dormitory, 0.7 mile downstream from the dam, based on these reports, is shown in figure 13.

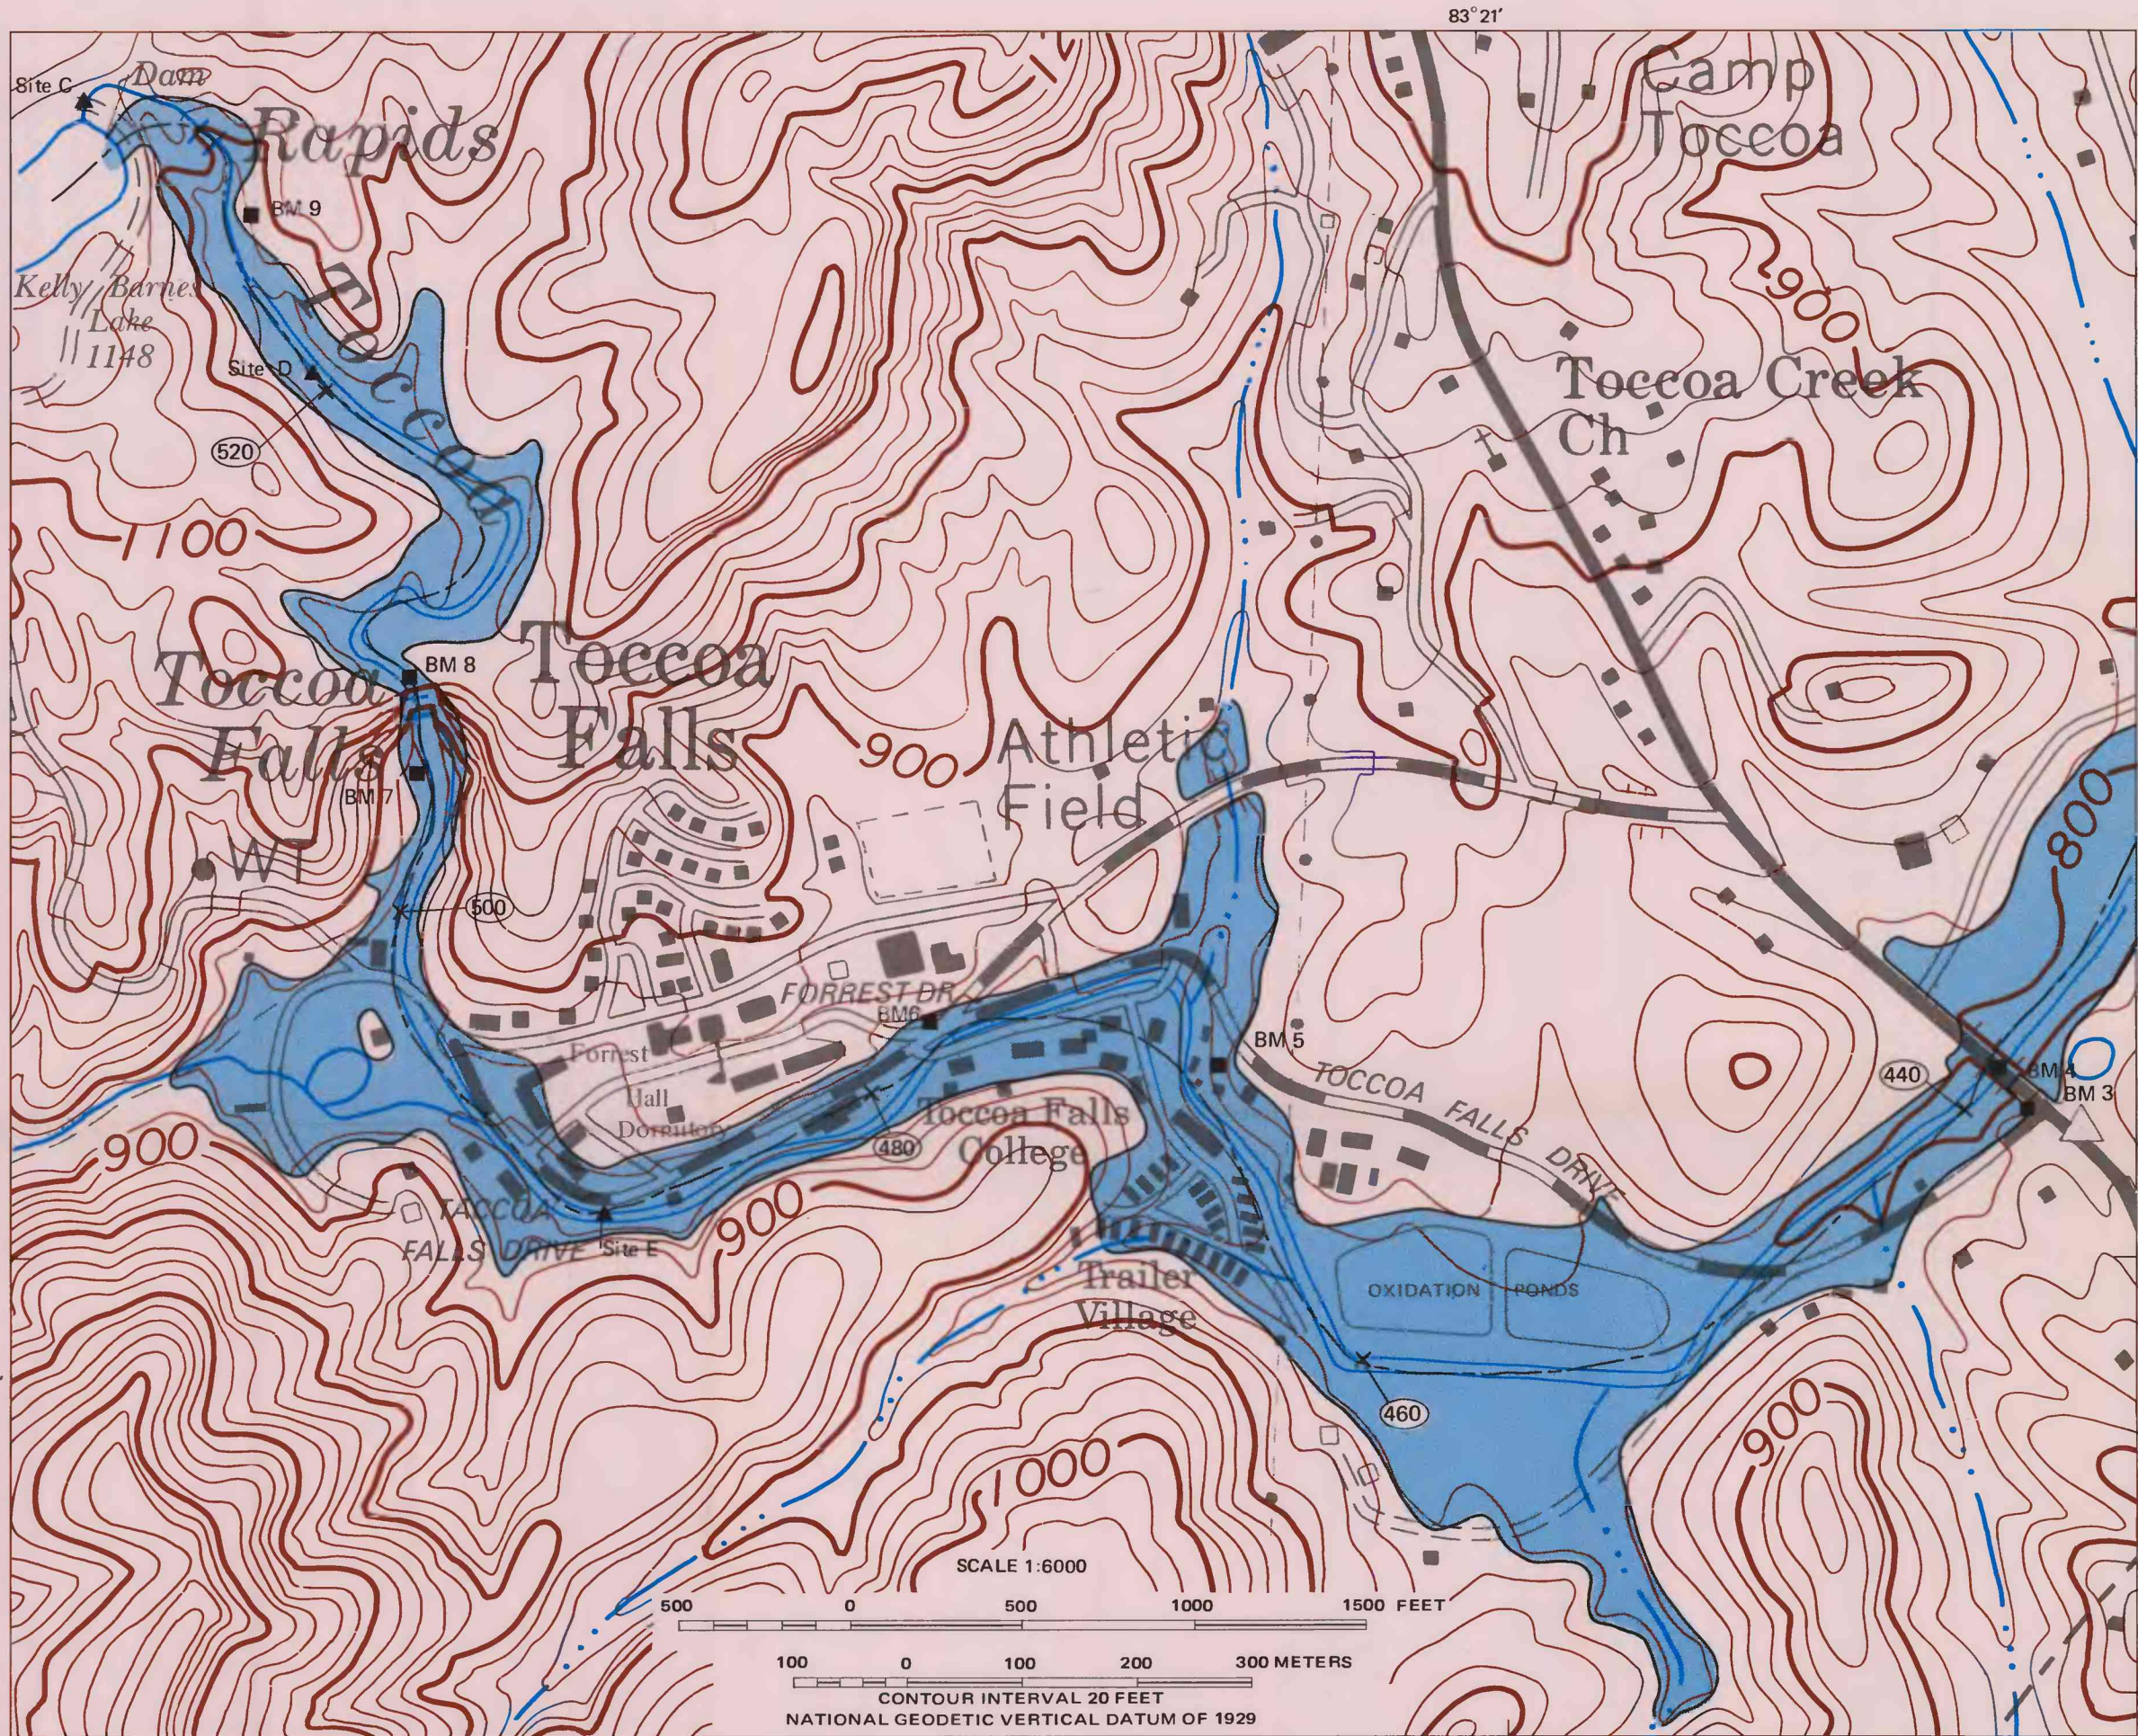
FIGURE 9.—Flood area from Kelly Barnes Dam to Georgia Highway 17.

**The Dam-Break Flood:** Between Kelly Barnes Dam and Highway Road the flooded area was defined by a survey of high-water marks (figs. 9 and 10). Seventy-two cross sections were obtained. A detailed analysis of peak discharges, flood frequency, and flood profiles is presented below.

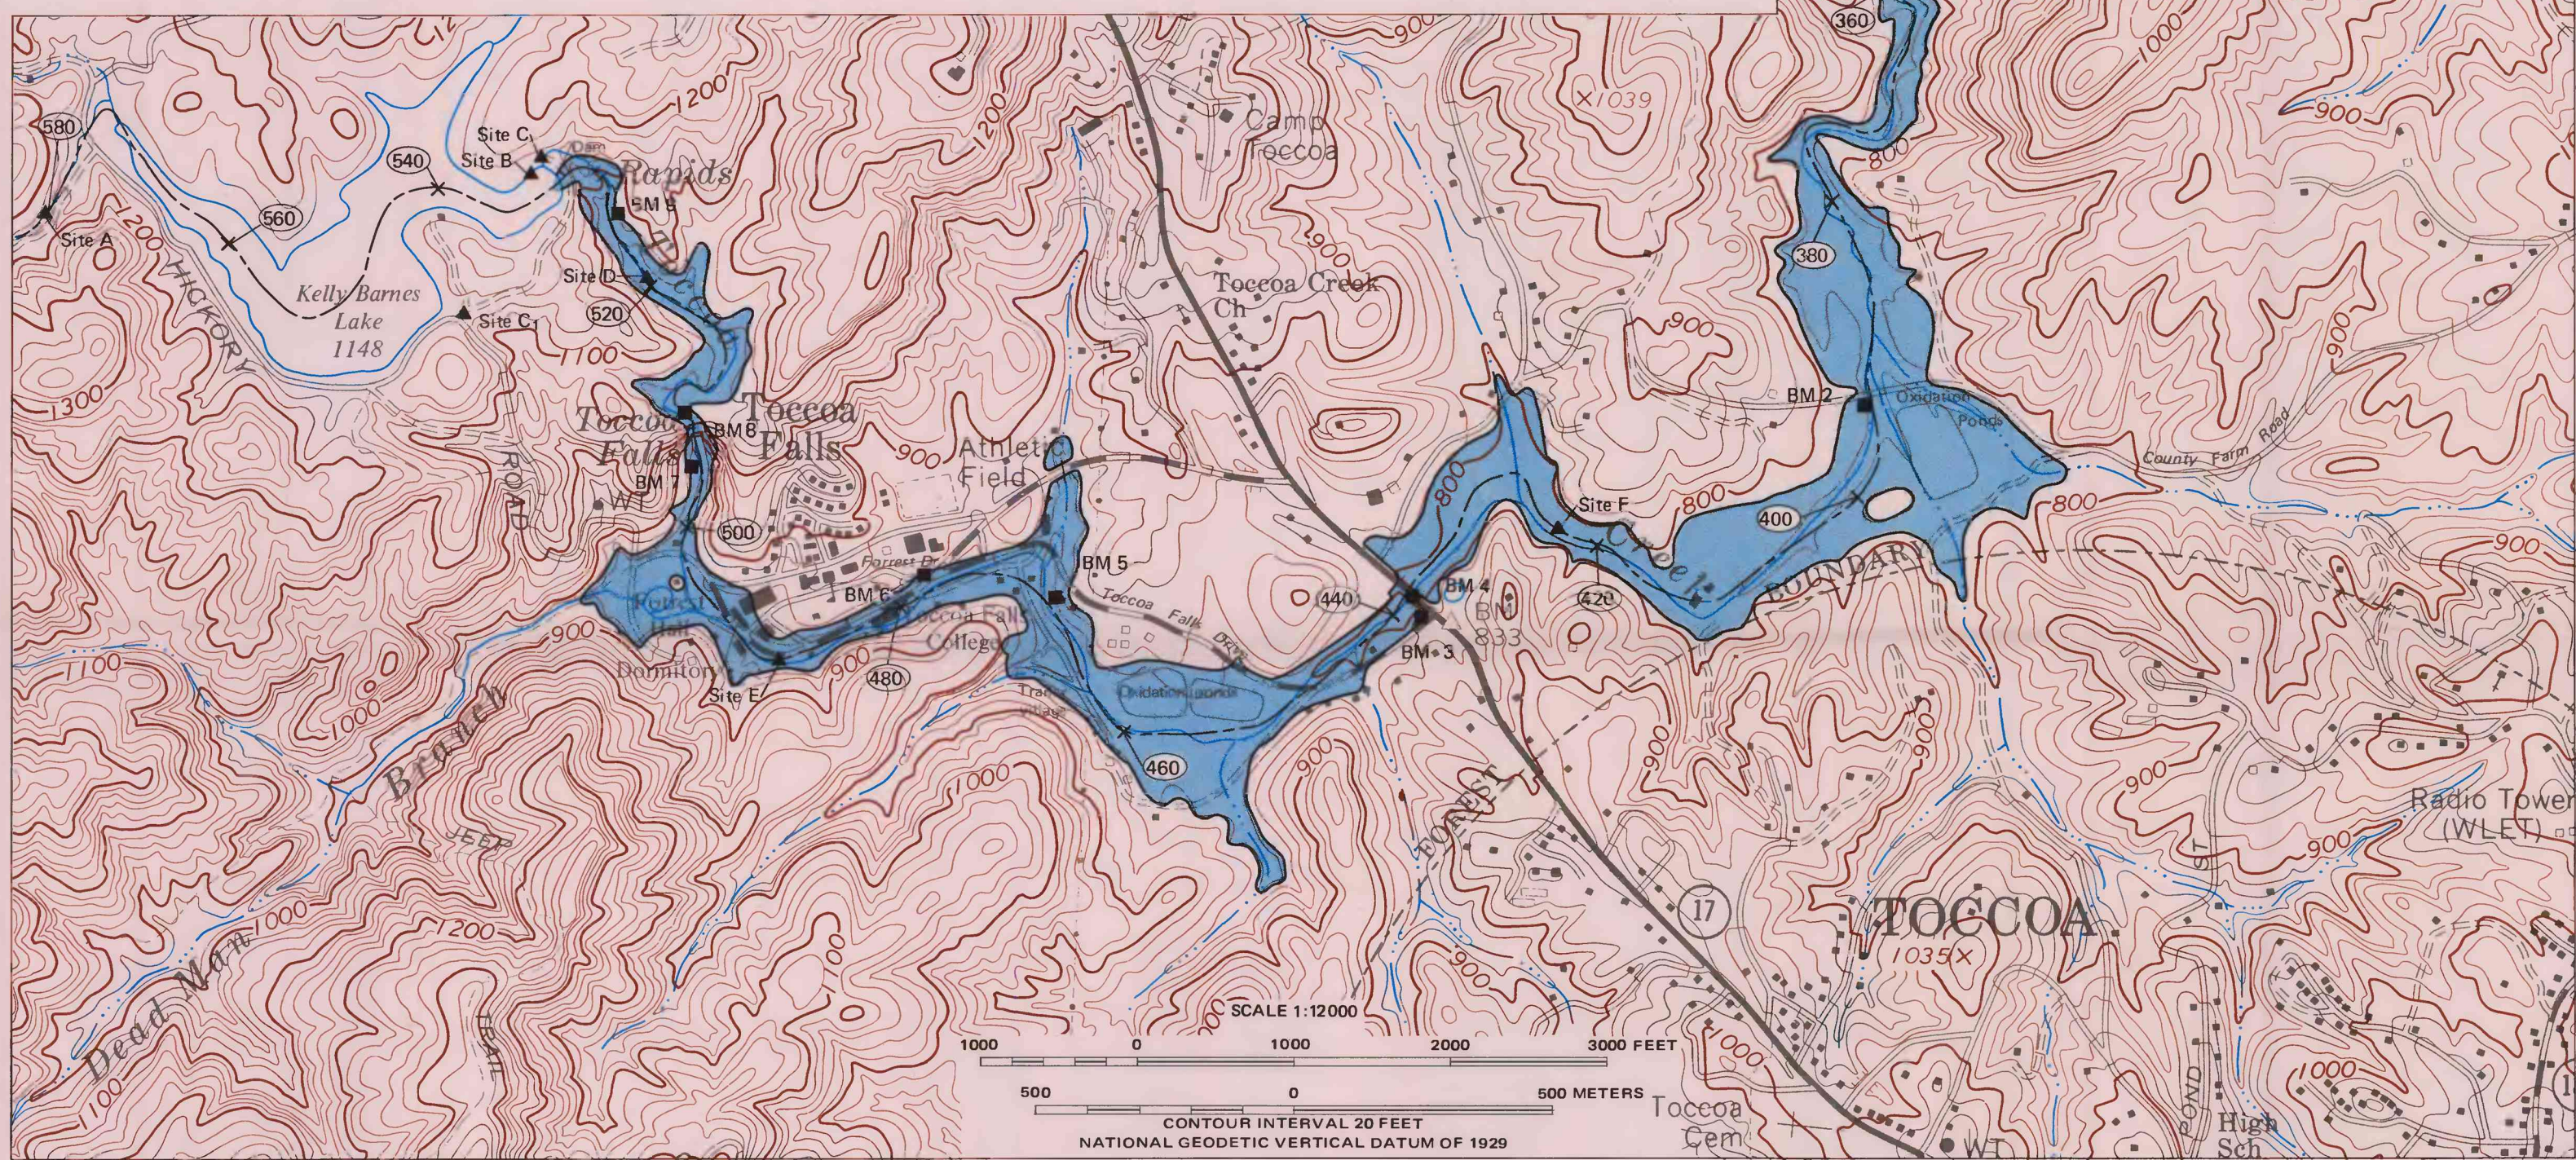
FIGURE 10.—Flood area from Kelly Barnes Lake to Highway Road.

**Peak discharges and flood frequency:** The peak discharges summarized in table 2 were computed on basis of cross sections, water-surface profiles, roughness coefficients, and, at some places, bridge geometry. Peak discharge measurement sites A-G are shown in figure 10. Site H is 1.6 mi downstream from site G and not shown in figure 10.

The peak outflow of 400 ft<sup>3</sup>/s from Kelly Barnes Lake before dam failure was estimated by means of slope-area and flow-over-crest computations at sites C and G, respectively. Flow occurred in both the primary earth spillway (site C) near the left end of the dam and the secondary spillway (site G).

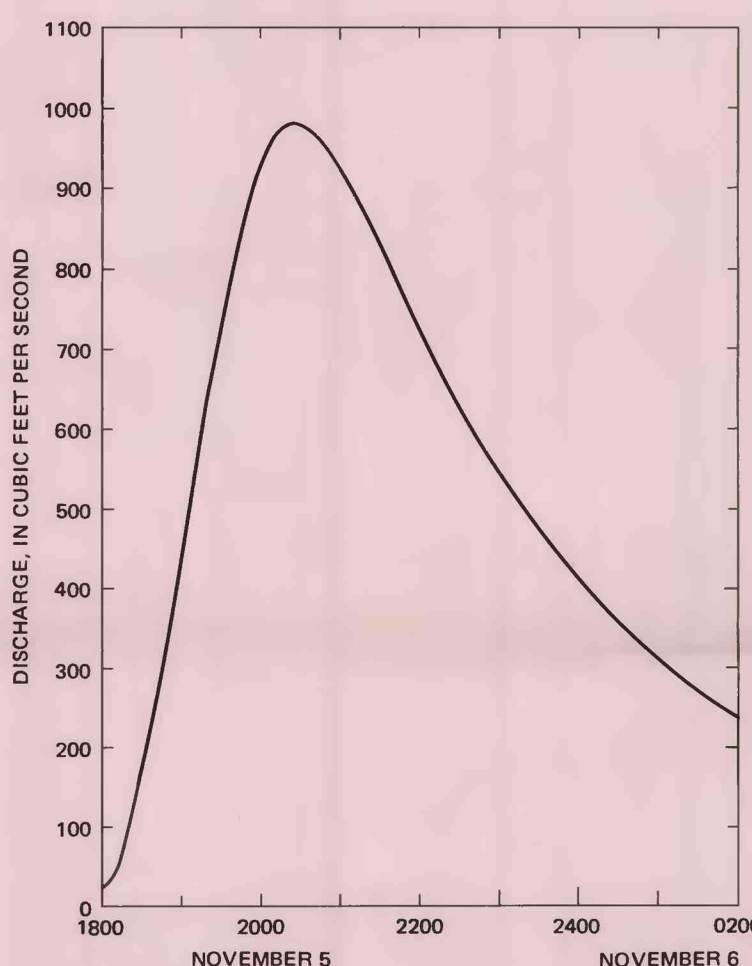
FIGURE 14.—Synthesized inflow hydrograph at site B, Toccoa Creek above Kelly Barnes Dam.

**The Flood Without Dam Break:** Streamflow estimated by rainfall-runoff model. Computations were made using a simplified version of the U.S. Geological Survey rainfall-runoff model (Dawdy and others, 1972) to develop a hydrograph of inflow to Kelly Barnes Lake for November 5-6 (fig. 14).

The model was calibrated by reproducing the observed discharge at site A of 830 ft<sup>3</sup>/s from Toccoa Creek into the lake. The model, with streamflow and reservoir routing techniques, was used to estimate discharges (fig. 12) in the reach between Toccoa Falls and Georgia Highway 17 that would have occurred if the dam had not broken, and also if there had been no dam.

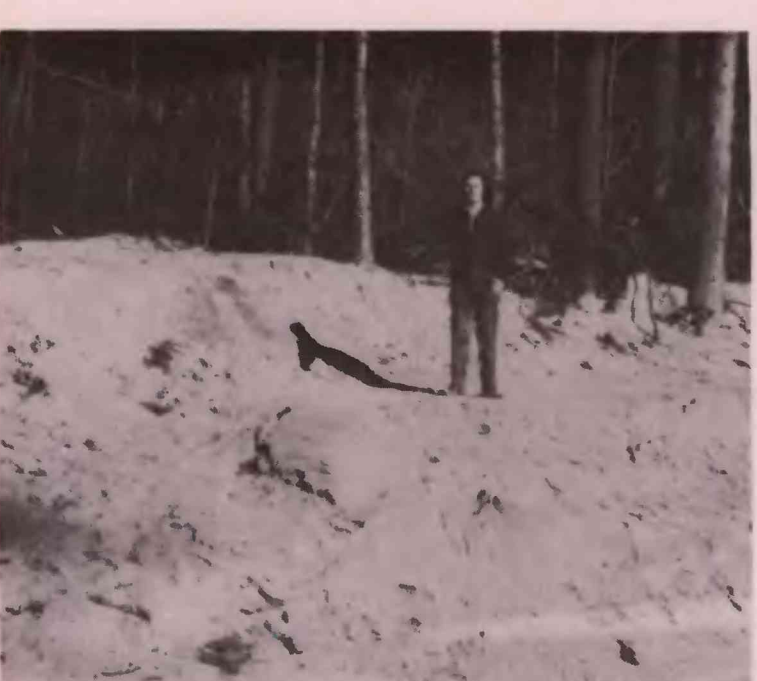
FIGURE 15.—Sand deposit 400 feet upstream from Toccoa Falls.

Sediment transported by the flood can be divided by particle size, source area, and mode of transport. Sand and finer material derived primarily from the breached dam, dissected reservoir deposits, and eroded soil cover were, for the most part, transported through the reach and over Toccoa Falls. These fine materials formed most of the wash load of the flood wave. Cobbles (64-256 mm) and boulders (larger than 256 mm) derived from the streambed and surrounding bedrock were moved only short distances and thus constitute the bed-material load of the stream. Gravel-size material that was derived from both the breached dam and the streambed forms a transition particle size between wash loads and bed-material load.

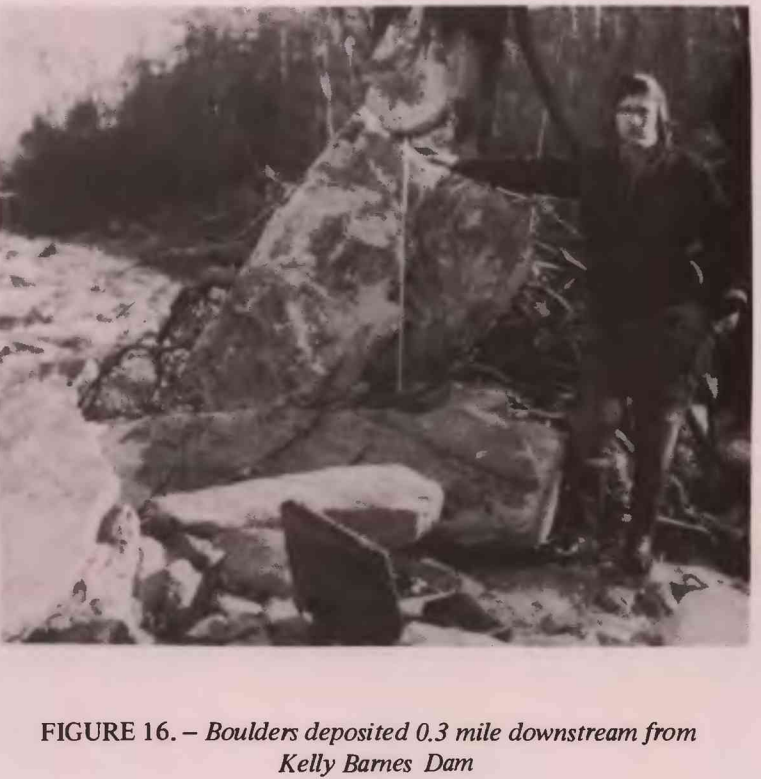
The breached section of the dam was a major source of gravel (2.0-64 mm), sand (0.062-2.0 mm), and finer material. Field measurements indicate that about 13,000 cubic yards of material was removed from the dam. Other sources of sediment in this size range include soil eroded from the valley walls and reservoir deposits that were eroded during stream incision. Most of the sand and finer material was transported over Toccoa Falls. One large deposit of sand, however, occurred on the inside of a broad bend about 400 feet upstream from Toccoa Falls. The areal extent of this deposit was not measured because of debris; however, its thickness is evident in figure 15. The relative amounts of gravel transported through or deposited in the reach cannot be reliably estimated. Deposits of gravel-size material are present throughout the reach, generally intermixed with larger material or in association with debris piles.

FIGURE 16.—Boulders deposited 0.3 mile downstream from Kelly Barnes Dam.

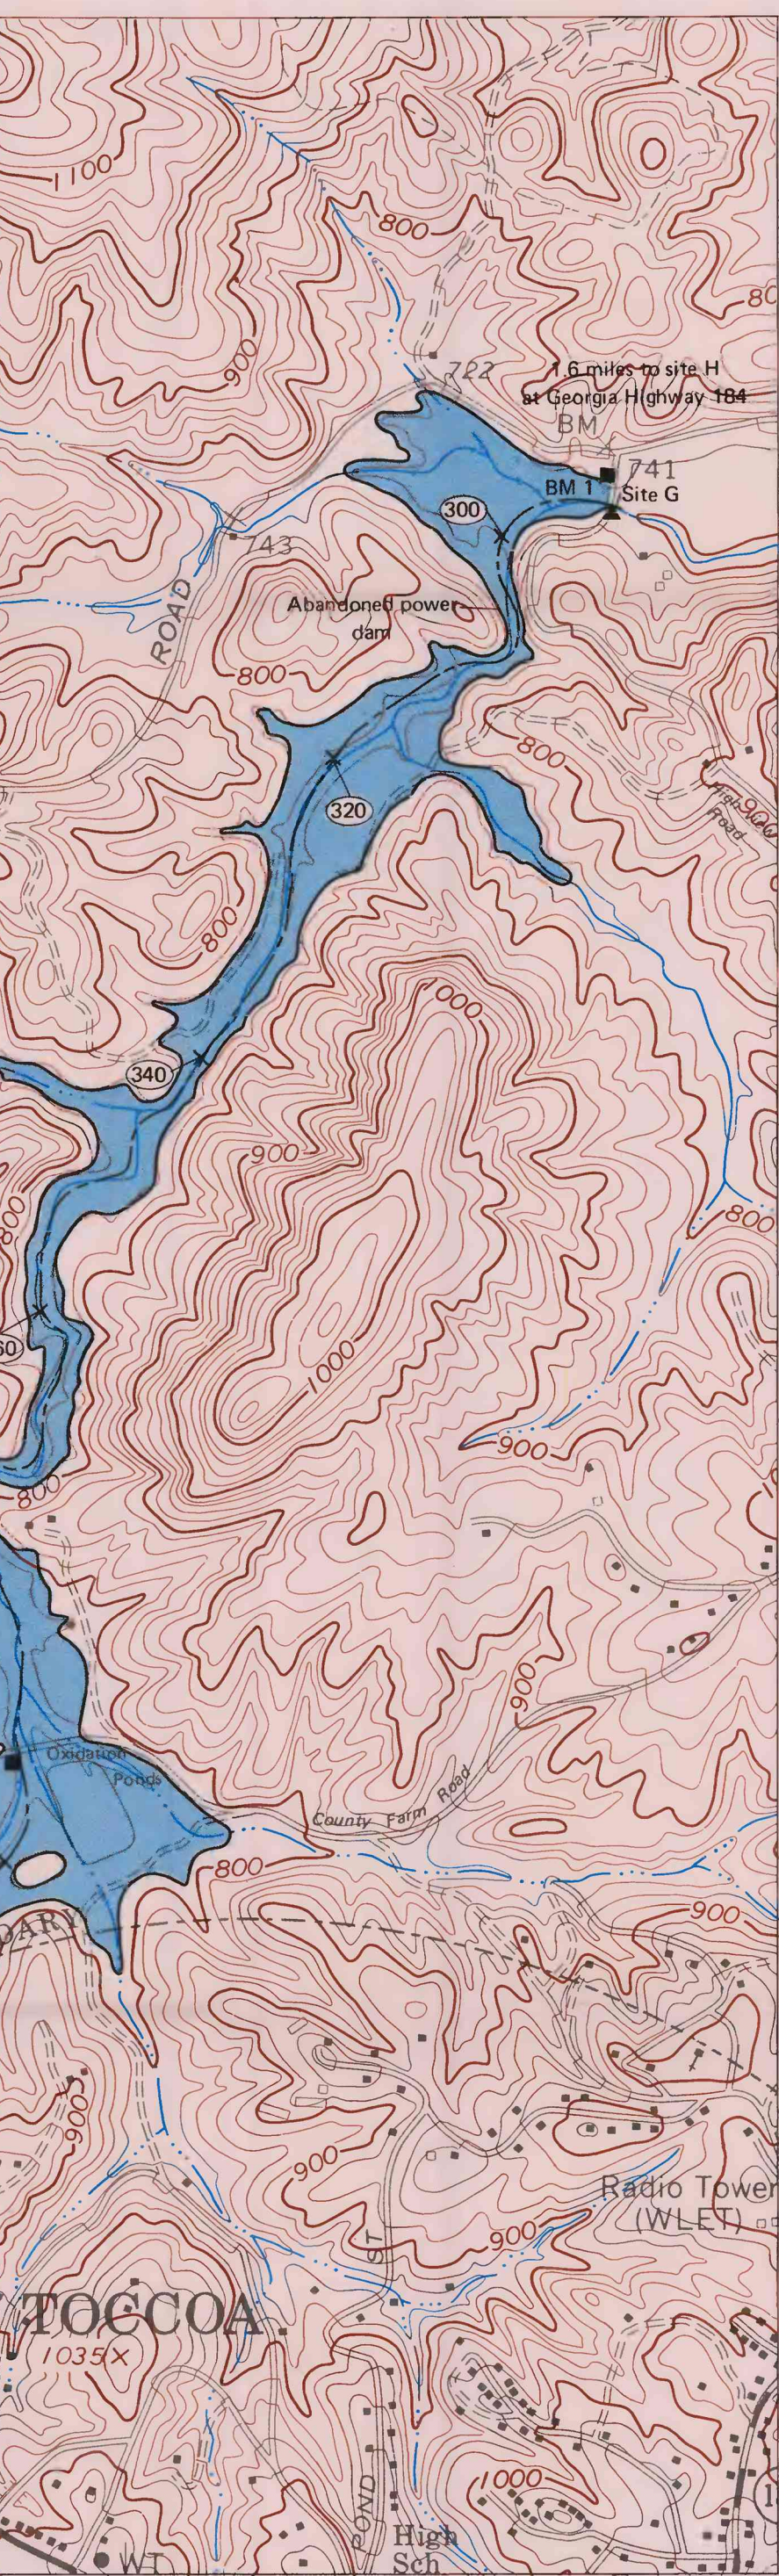
**Flood profile:** Water-surface profiles, determined from a field survey of high-water marks left by the flood of November 6, are shown in figure 11. Average depths in the main channel above Toccoa Falls were about 17 feet. Depths in the vicinity of the college ranged from about 21 feet at Forrest Hall Dormitory to 18 feet at the trailer village. Depths downstream from Georgia Highway 17 averaged about 15 feet.

Controls for pool-and-riffle flow are located near stations 517, 486, 480, and 465 and at Georgia Highway 17. These controls are at obvious valley constrictions, but some of the resulting backwater could have been caused by temporarily lodged debris. Extreme scour was evident at these controls.

Water-surface elevations on the left bank differed from those on the right bank by as much as 10 feet in the curves along the main channel because of superposition resulting from high velocities. However, even in these high-velocity areas, ponded conditions existed in nooks near the mouths of tributaries.
